NASA Technical Memorandum 103242 AIAA-90-2586

# Requirements for Long-Life Operation of Inert Gas Hollow Cathodes— Preliminary Report

Timothy R. Verhey Sverdrup Technology, Inc. Lewis Research Center Group Brook Park, Ohio

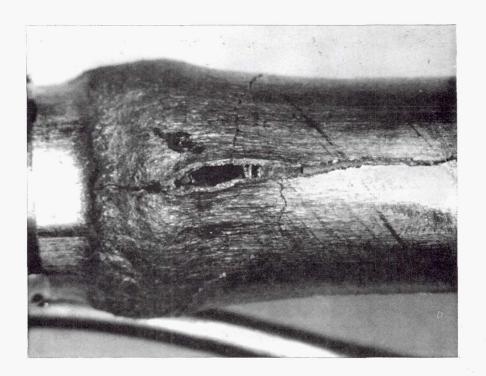
Table I summarizes the reported life-testing of hollow cathodes on inert gases and lists the life-limiting phenomena that have been experienced in several instances of device testing. Ramsey<sup>13</sup> and Beattie, et al.<sup>14</sup> have observed cathode orifice erosion over the course of extended tests with xenon propellant. Rawlin observed destructive oxidation of the cathode body tube in the form of cracking and swelling as can be seen in Fig. la<sup>15</sup>. The damage was believed to be a consequence of contamination due to atmospheric leaks into the feed system and an improper insert activation procedure. Brophy and Garner found similar cathode body tube swelling and cracking after 500 hours at a 100 A operating point<sup>16</sup>. In recent tests<sup>17</sup>, anomalous material formation was found to have occurred within the cathode and at the orifice of the cathode. A photograph of the formation is shown in Fig. lb. This material is believed to be a barium tungstate resulting from the reaction of the insert material with liberated barium and contaminants in the propellant feed system such as water vapor and oxygen. The above-mentioned phenomena may be facility-related. As a consequence, these issues must be addressed before meaningful long-term life-testing of the hollow cathodes can be undertaken.

Figure 1. Examples of hollow cathode operational problems. Photo a. shows a tantalum hollow cathode tube that has swelled and cracked due to oxidation. Photo b. displays build up of anomalous material at a cathode orifice which occurred in operation.

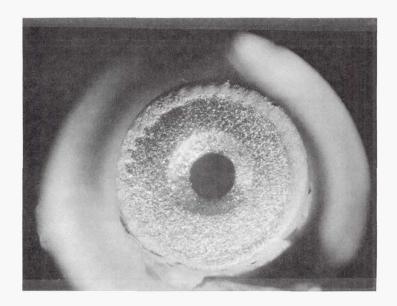
Figure 10. Condition of the hollow cathode orifce plate. Photo a. is of a cathode orifice plate with no operational time. Photo b. is the orfice plate after the 500 hour weartest.

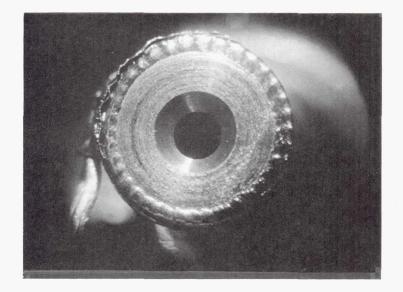
b.

Fig. 10 shows the orifice plate before and after the test. From the figure, it can be seen that substantial texturing of the orifice plate had occurred. It was also found that, over the course of the test, the ignitor electrode had sagged and begun to intercept the cathode plume on one side. Substantial erosion of the ignitor electrode occurred, leading to deposition of the electrode material over the surfaces of the simulator chamber.

An extended wear test of a hollow cathode was conducted in the vacuum facility described. The duration of the test was 504 hours, over two segments. The emission current was set at 23.0 amps. The discharge voltage was initially 15 volts but rose continuously to approximately 21 volts by the conclusion of the test. The temperature of the hollow cathode was a relatively constant 1160 °C over the duration of the test. No component failure was experienced by the completion of the test, but texturing of the orifice plate had occurred.
